HA-537
OLD ORDINARY
Havre de Grace, Md.

c. 1800

INVENTORY FORM FOR STATE HISTORIC SITES SURVEY

100 St. John Street

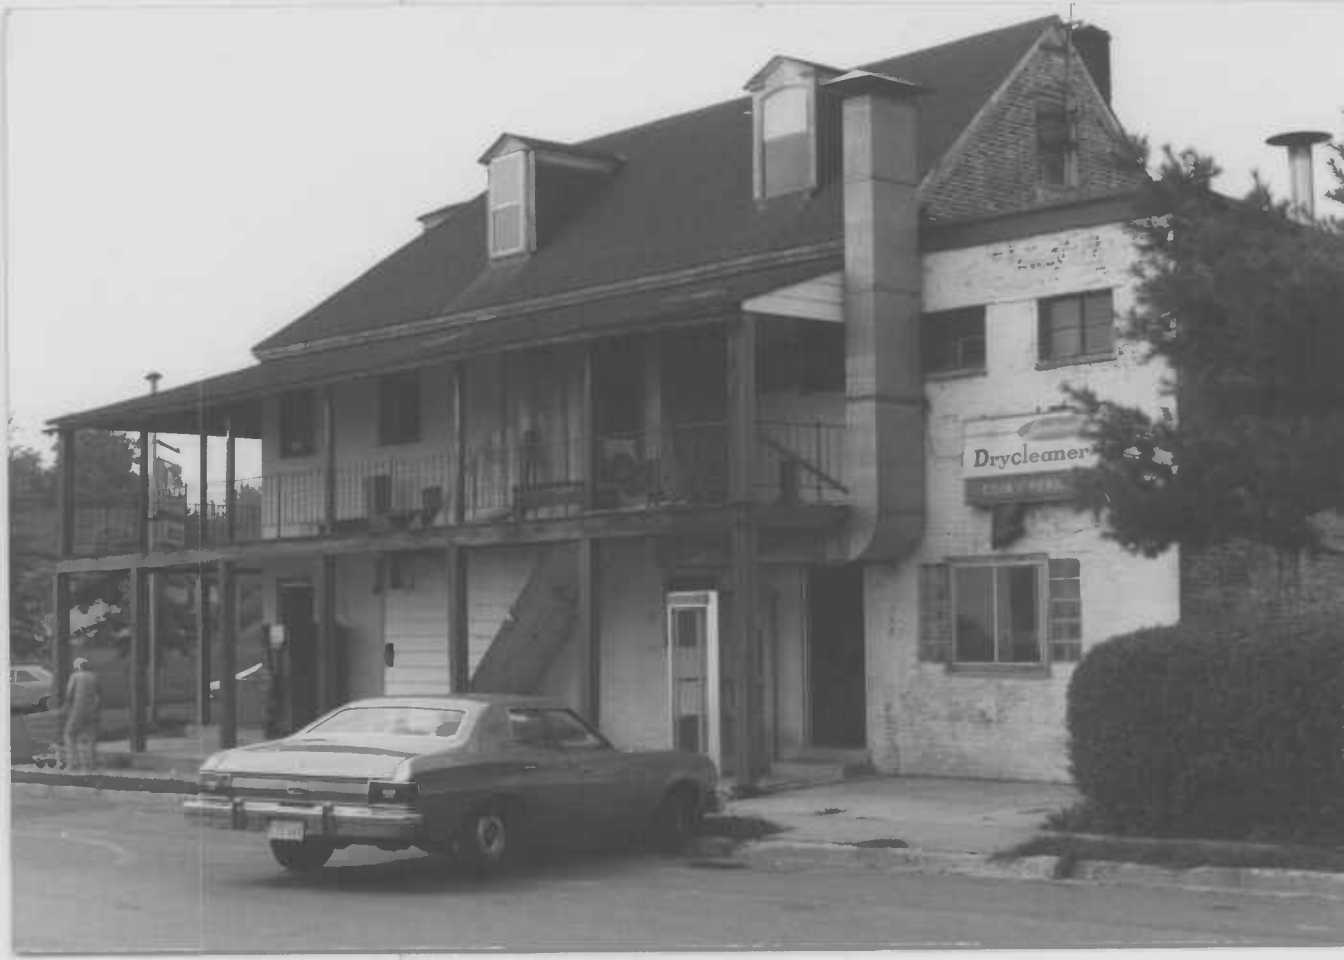
117
Old Ordinary

100 St. John St. is a two and half story, five bay by two bay detached brick building with a half hipped, half gable roof, facing east on the corner of St. John St. and Congress Ave. A two story brick wing joins the structure on the north elevation. During the last forty years, the fenestration on all elevations has been severely altered and two cinder block additions have been added to the rear. The walls, painted white on the front and south elevation, are common bond.

Northeast Elevation

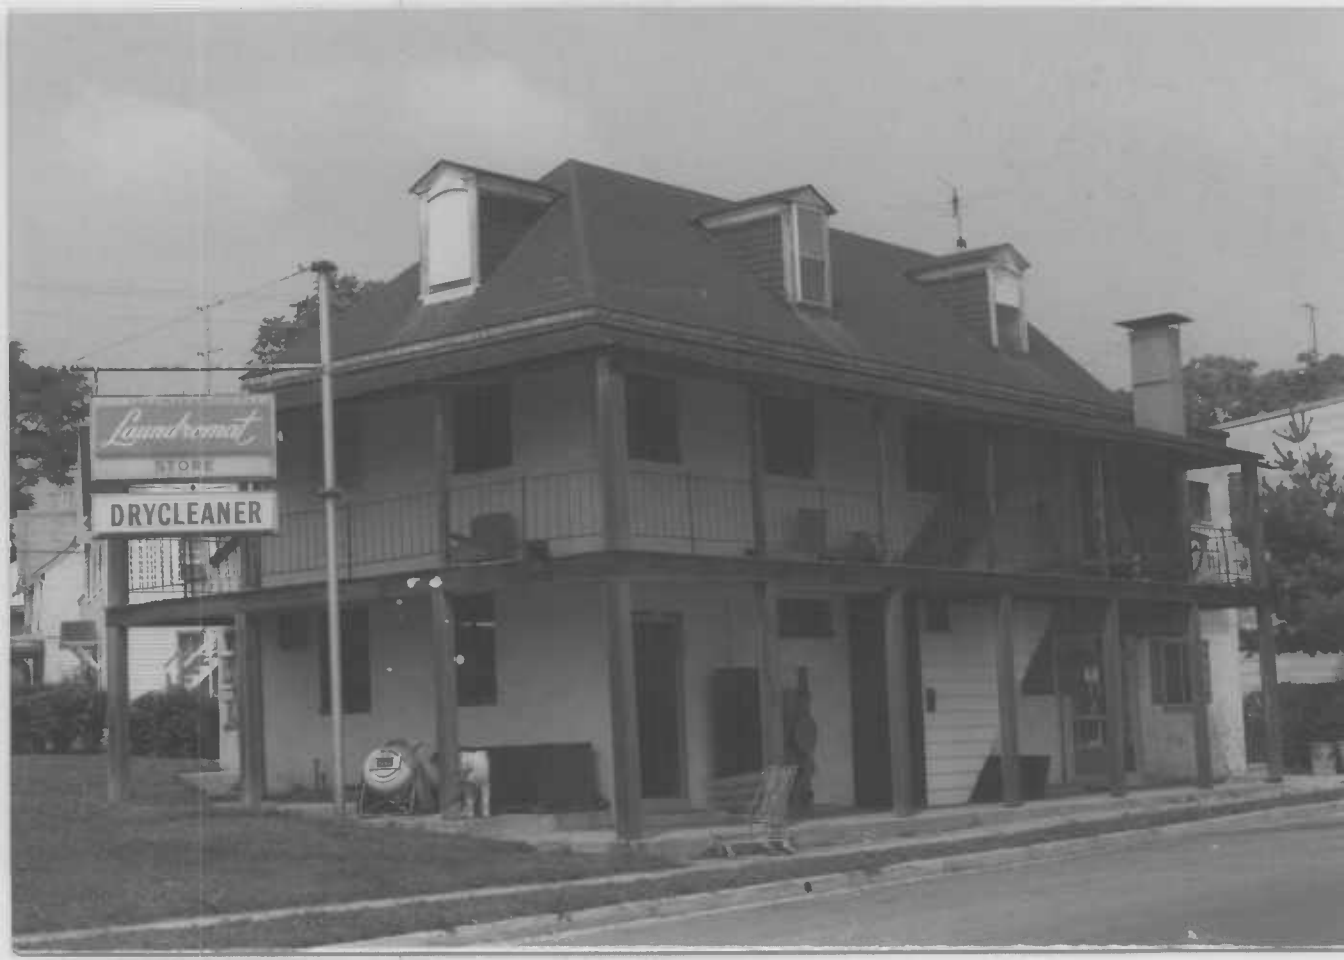
Old Ordinary

A two story, six bay porch extends across the facade and around the south elevation. It has a shed roof extending from the eaves of the roof. Recently, the wood railing on the second story was replaced with metal.

All of the window openings have been changed by the addition of small casement or stationary sash windows with the exception of the 6/6 light, double hung sash, gable window in the north elevation and five dormer windows in the roof. A copy of a HABS photograph (1936) shows a large window with double hung sash flanked by two part, folding paneled shutters. The east elevation windows appear to have wide molded jambs and flat wooden lintels and sills.

Southeast Elevation

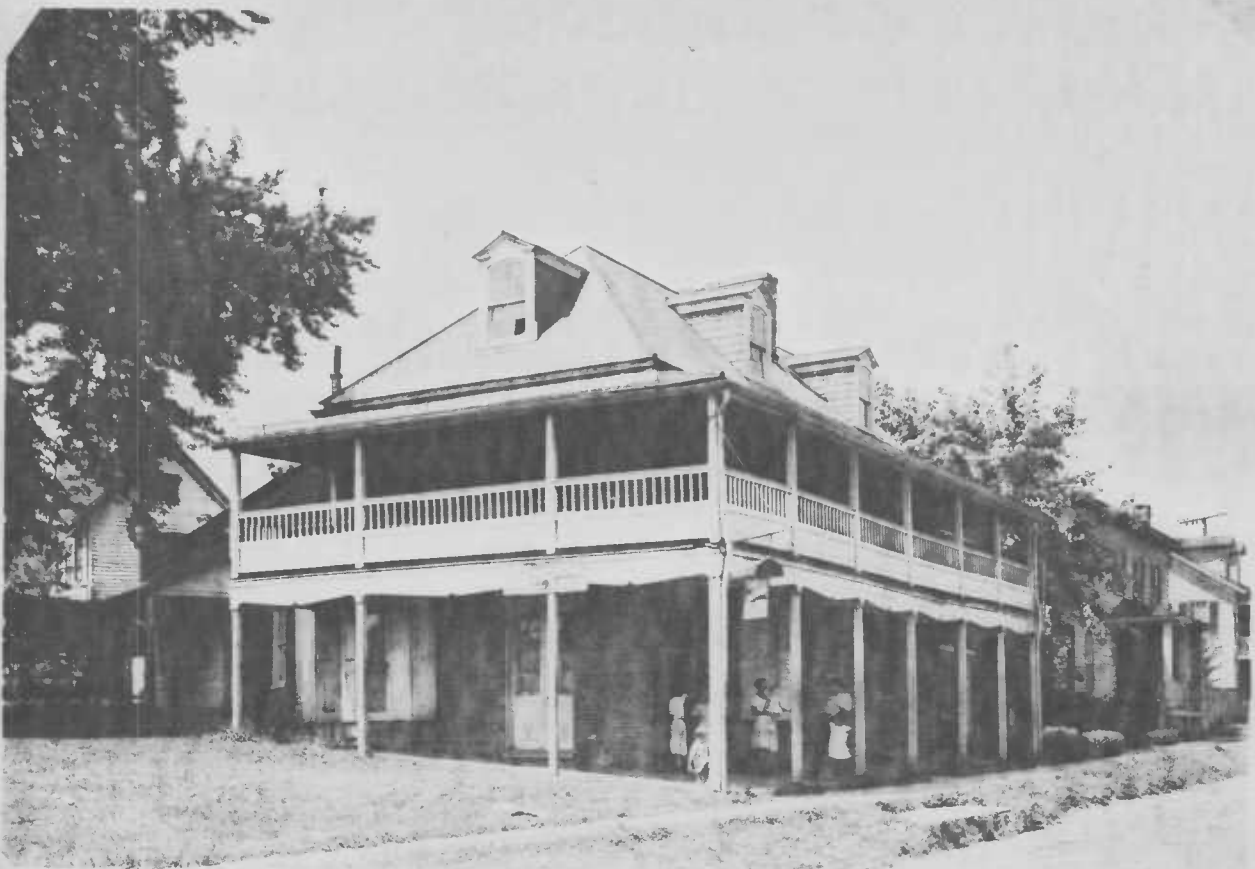
HABS No. Md.
HA-537

The main entry in the HABS photograph is in the east bay, south elevation. It had double paneled doors with eight lights in each of the upper panels. Today this door opening is a window, three other openings having been cut out of the east elevation.

The building has a hipped roof with a gable on the north end and a three course brick cornice. The roof retains five dormers with triangular pediments and round arched windows; the two rear dormers have 6/6 light sash while the dormer on the south and the two on the front are boarded over. Although the main block no longer has a chimney, a rectangular brick central chimney is visible in the HABS photograph.

Old Ordinary
Waterfront
Havre-de-Grace, Maryland.
